Diagnosis and structural recuperation of foundation blocks under attack by AAR in a Brazilian building

Keywords: AAR, blocks, concrete, foundations, pathology.

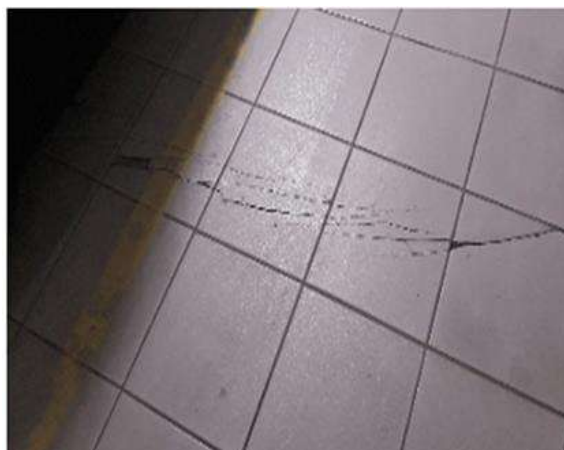
The pathology was discovered during a routine inspection contracted by the outsourced company that manages the building. The inspector became suspicious of cracks, as shown in Figure 3.1, found on the garage floor of the building's basement and requested an inspection to see what, in fact, was causing them.

Figure 3.1: Cracks on the floor

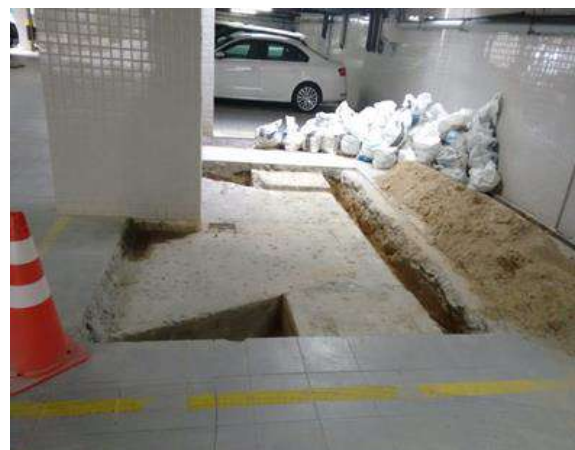
Figure 3.2: Partially exposed block

During this inspection, two foundation blocks were excavated in order to diagnose the pathology, as shown in Figure 3.2. Four samples were extracted (shown in Figures 3.3 and 3.4) and later sent off for laboratory tests to the ABCP - Brazilian Association of Portland Cement [5], in São Paulo, for diagnosis and verification of the reactive potential of the aggregates.

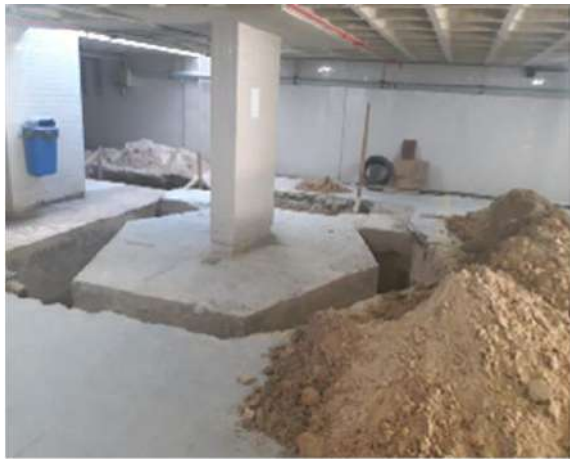
Figure 5.1: Exposed foundation block

After excavating the block (Figure 5.1), it was cleaned with a high-pressure washer in order to remove all types of residue from its surface, as shown in Figure 5.2, and to open its pores for better penetration of the structural adhesive and afterwards, better adhesion of the waterproofing.

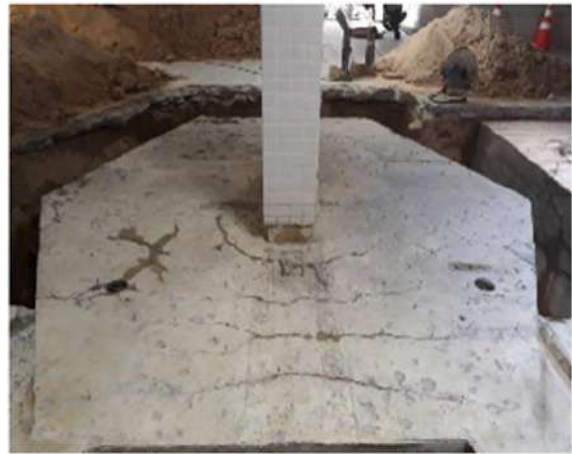
Figure 5.2: Block surface after cleaning

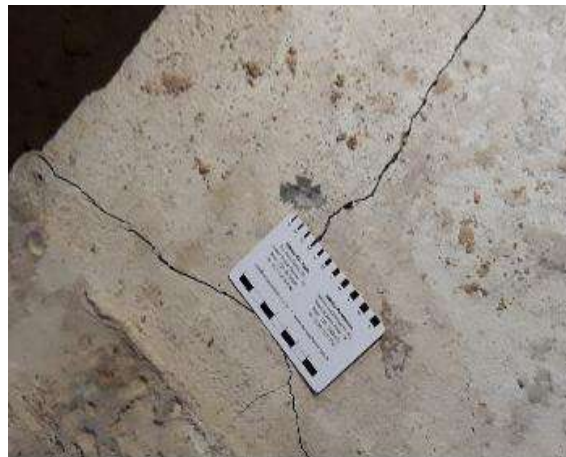
The width of the block's cracks was measured with the aid of a fissurometer and was on the order of 1.8 mm, as shown in Figure 5.3.

Figure 5.3: Crack measurements performed by fissurometer

Even when concrete appears to be severely cracked and visibly deteriorated, the structural effects, may be negligible [8] thus a calculation engineer should be consulted. The type of repair to be performed was determined by the calculation engineer responsible for the structure. The solution recommended was to inject epoxy resin to seal the cracks, as this method would best suit the width of the cracks found in the block. The possibility of encapsulating the block was considered, as there was a possibility that the reinforcement had been exposed and lost part of its load capacity. The concrete could also have lost some strength due to the tensile forces it suffered when the block expanded.

The engineer measured the widths of the cracks on the face of each block and then divided the total width by the size of the block face. This calculation led to the conclusion that it would not be necessary to encapsulate any of the blocks because the cracks were quite narrow. It was recommended, however, that all blocks be waterproofed with a product having a greater ability to support expansion in order to ensure that any future cracks would not compromise the waterproofing of the block.

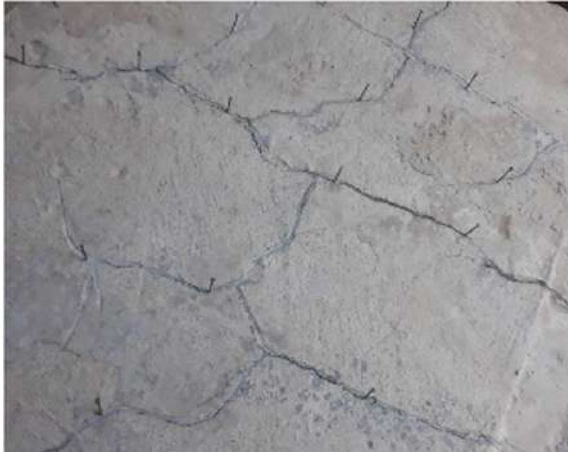
Figure 6.1: Open cracks

The width of the cracks was increased with the use of a sander to allow for greater adherence between the block and the materials used in the recuperation. Subsequently, nails were placed on the surface of the block to mark the cracks, as shown in Figure 6.1, and to allow the attachment of the adhesion nozzles shown in Figure 6.2.

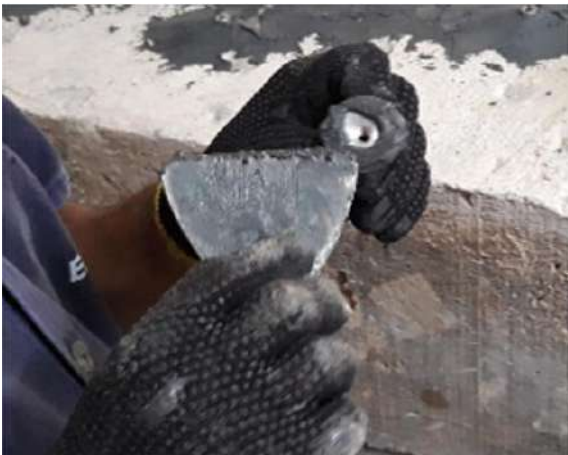
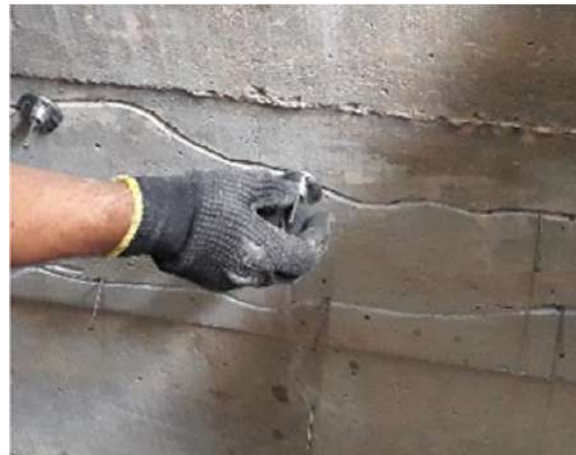
Figure 6.3: Nozzles with structural adhesive

Figure 6.4: Attaching the adhesion nozzles

Structural adhesive was used to fix the nozzles to the block, as shown in Figures 6.3 and 6.4. This procedure was performed on the top and sides of each block recuperated. The external cracks in the block were sealed with structural adhesive immediately after attaching the nozzles.

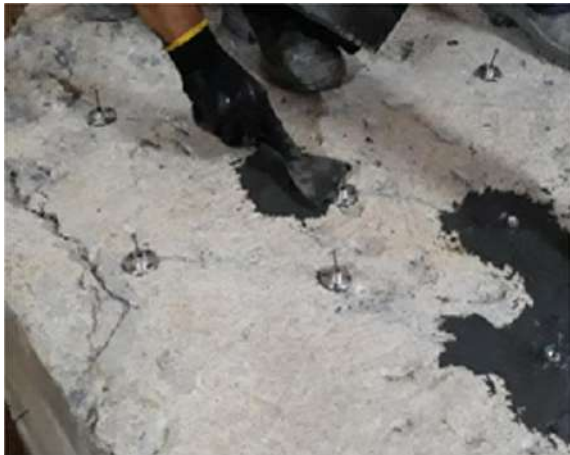
Figure 6.5: Application of structural adhesive to cracks

This adhesive (the same used to attach the adhesion nozzles) seals the cracks, preventing the escape of the filling material. The product is an epoxy-based adhesive with medium viscosity, has a compressive strength of 70 MPa after 7 days and an adhesion resistance to concrete ≥ 2.2 MPa. It is contained in two packages that were manually mixed and then applied to the block to seal the cracks using a spatula, as shown in Figure 6.5.

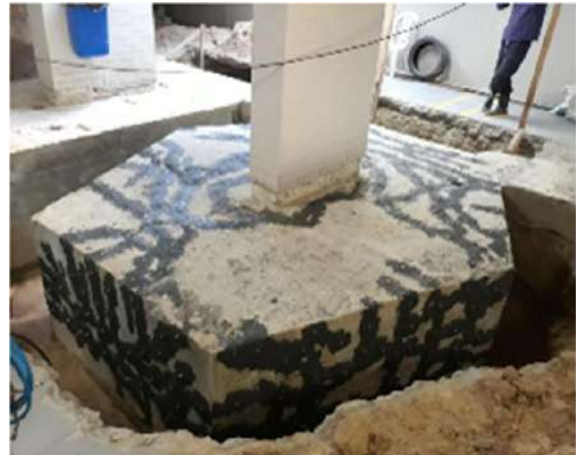
Figure 6.6: Block following crack sealing

After sealing all external cracks on the top and sides of the block with structural adhesive, as shown in Figure 6.6, epoxy resin was injected.

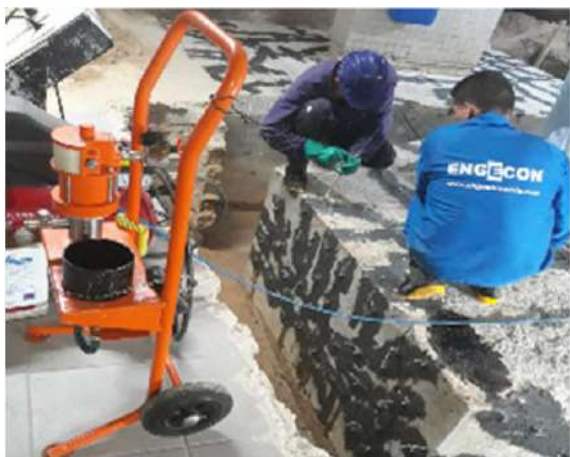
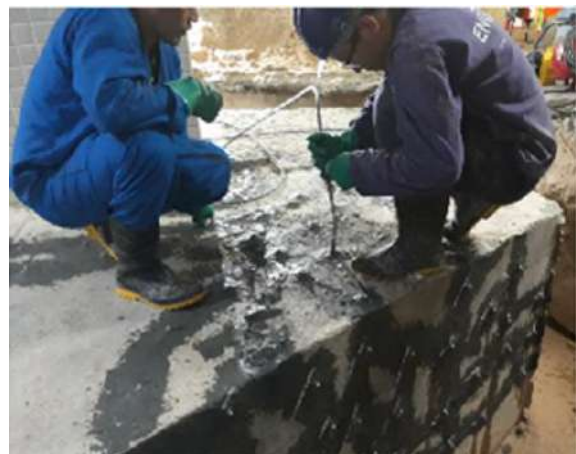
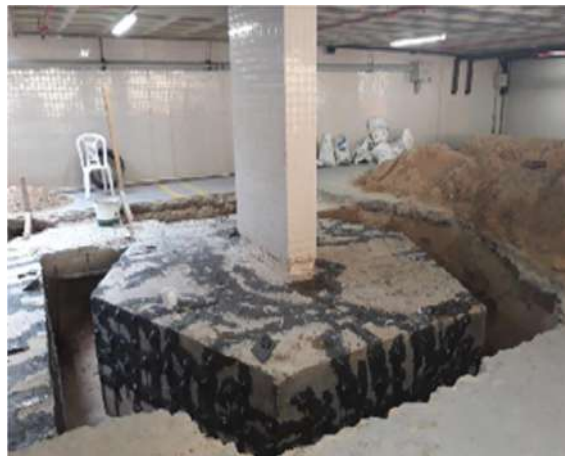
Figure 7.1: Use of Injection pump to apply epoxy resin

Figure 7.2: Injection of epoxy resin into the foundation block

Figure 7.3: Foundation block with cracks filled with epoxy resin

The epoxy resin was injected into the block with an injection pump. The resin penetrated the blocks through the nozzles, filling all internal cracks in the block, as shown in figures 7.1 and 7.2. Figure 7.3 shows the block with all cracks sealed.

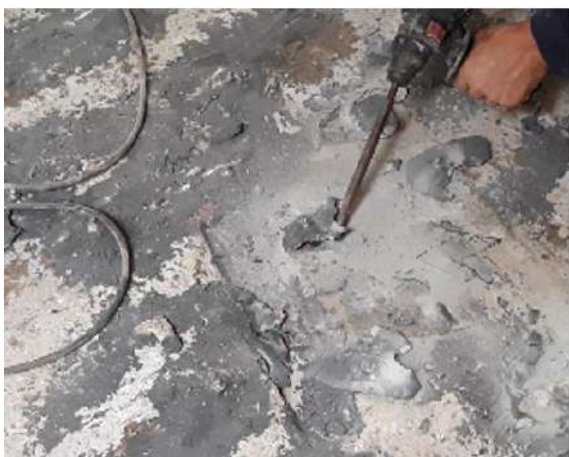
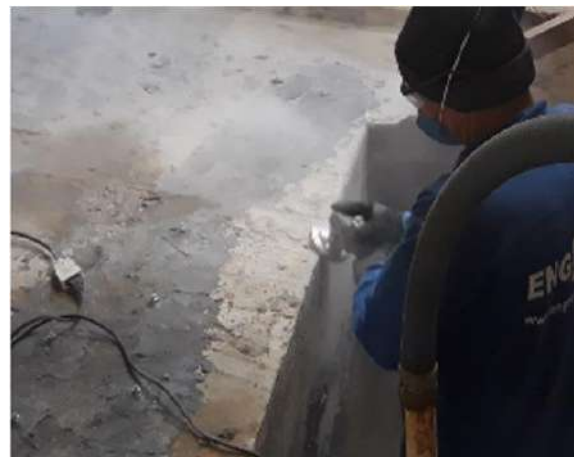
Figure 8.1: Removing the adhesion nozzles

Figure 8.2: Regularization of block surfaces and corners using a sander

Before applying the indicated waterproofing product, it was necessary to completely remove the adhesion nozzles (Figure 8.1), clean and regularize the surface of the block to ensure that there were no points that would perforate the waterproofing layer. The side surfaces were sanded (Figure 8.2) and then cleaned with a compressor to remove particles of dust and cement laitance from the block.

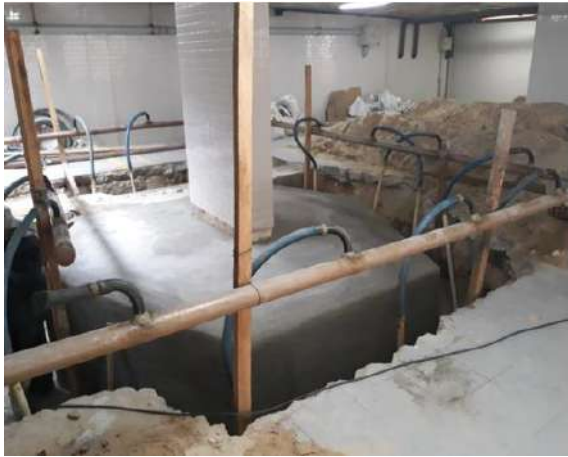
The level of the water table beneath the structure was high. Through the opening in the block, it could be seen that about 30 centimeters of the block were immersed in water and that it would therefore be necessary to lower the water table. A pump was used to ensure that the block remained dry until the end of the reinforcement process (see the drainage device in Figure 8.3). It is also possible to observe in this figure the clean and regularized surfaces, ready for waterproofing.

Figure 8.3: Groundwater lowering system

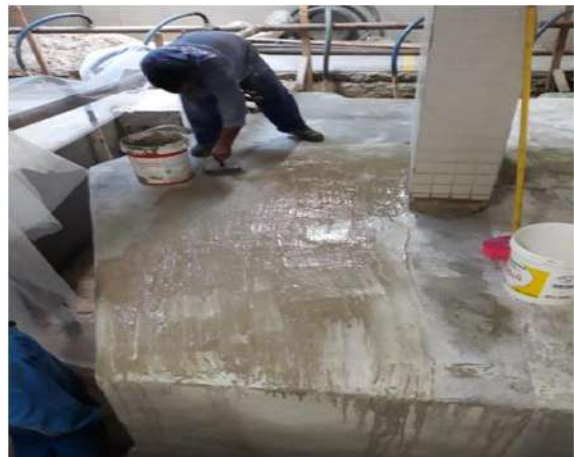
Figure 8.4: Application of waterproofing product

The waterproofing product must be applied to a clean surface with the aid of a compressor and spread with a brush. The waterproofing product (made of a liquid and a powder), must be mixed with a low-speed mechanical mixer until a homogeneous mortar is obtained. One layer of this product was applied evenly to ensure full coverage of the surface, as shown in Figure 8.4.

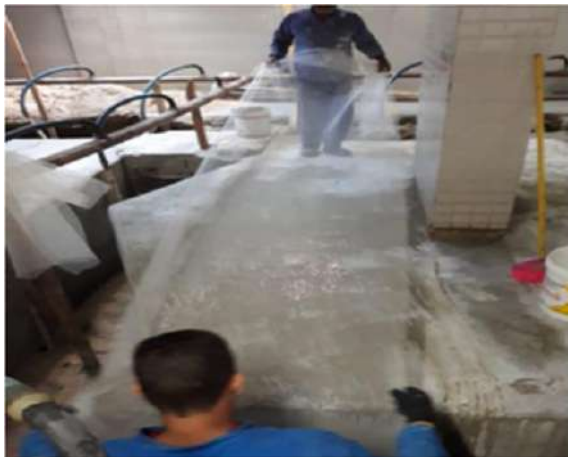
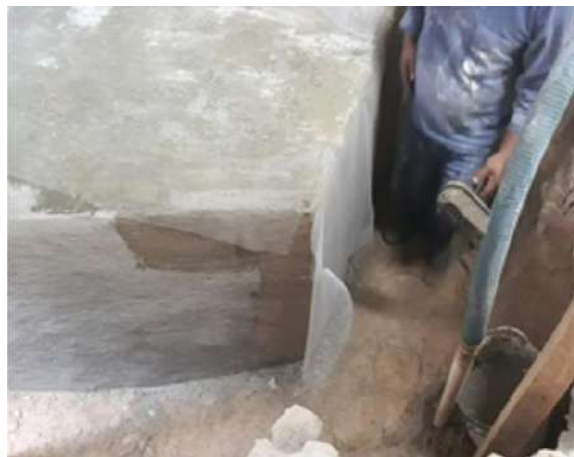
Figure 8.5: Screen being applied to the block

Figure 8.6: Screen being applied to the block corners

To maximize the efficiency of the waterproofing, a PVC-coated polyester canvas was also used. This screen was measured and cut to cover the required surface, especially the corners, and applied immediately after the first coat of the waterproofing product was applied (Figures 8.5 and 8.6).

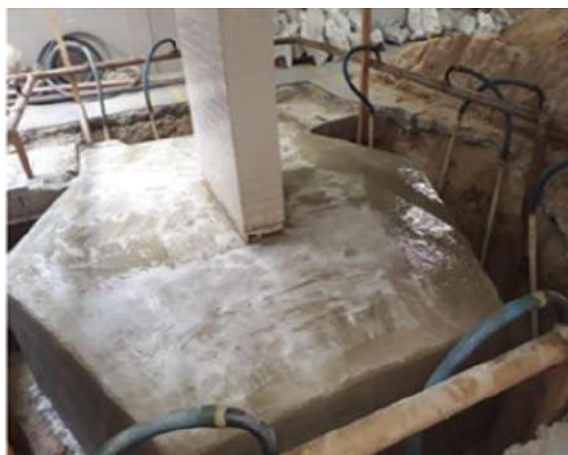
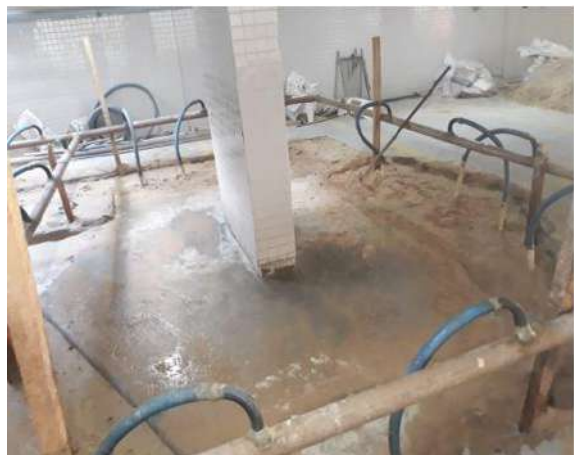
Figure 8.7: Block after waterproofing

Figure 8.8: Block finished and reburied

Subsequently, three more coats of the waterproofing product were applied, making a total of four. In Figure 8.7, the block was completed. The curing of the product was monitored for seven days and then the block was reburied (Figure 8.8).

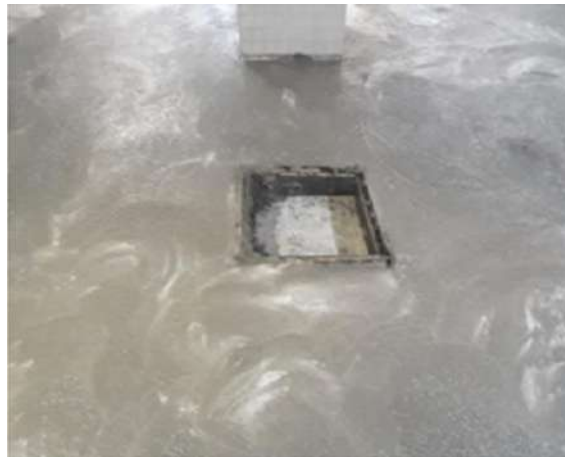
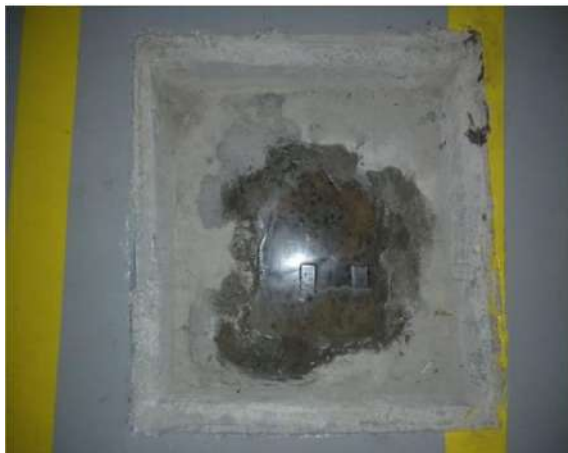
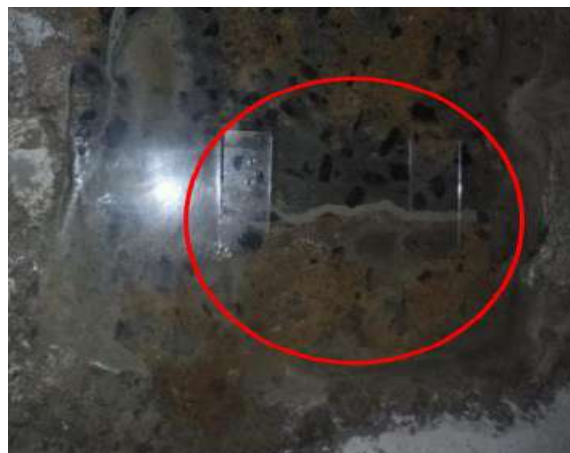
Figure 9.1: Construction of the floor and inspection window

Figure 9.2: Inspection window

Figure 9.3: Detail of the sealed crack

The last step was the reconstruction of the floor and creation of the inspection window. This window is necessary because AAR is a pathology still lacking a definitive solution. Repair is palliative and it is still possible for the block to expand again. The size of the window was chosen (50 cm x 50 cm) and a wooden form was constructed so that the block would be completely exposed (the detail at the bottom of the form can be seen in Figure 9.1).

The inspection window was positioned to expose the largest crack in the block, shown in Figure 5.2. To do this, the bottom part of the formwork was sanded until the mortar was removed, making the crack visible (see details of the crack exposed in Figure 9.3). After removing the formwork and finishing the floor, a thin plate of glass was placed over the crack and waterproofed using epoxy resin (shown in Figure 9.2). If the block begins to expand again, the glass will crack, revealing this expansion.
