Diagnosis and structural recuperation of foundation blocks under attack by AAR in a Brazilian building

Keywords: AAR, blocks, concrete, foundations, pathology.

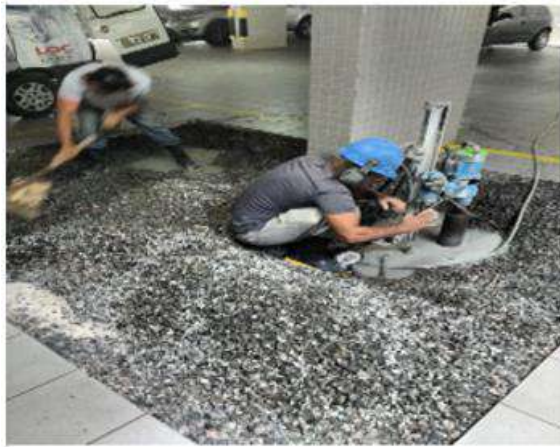
During this inspection, two foundation blocks were excavated in order to diagnose the pathology, as shown in Figure 3.2. Four samples were extracted (shown in Figures 3.3 and 3.4) and later sent off for laboratory tests to the ABCP - Brazilian Association of Portland Cement [5], in São Paulo, for diagnosis and verification of the reactive potential of the aggregates.

Figure 3.3: Sample extraction

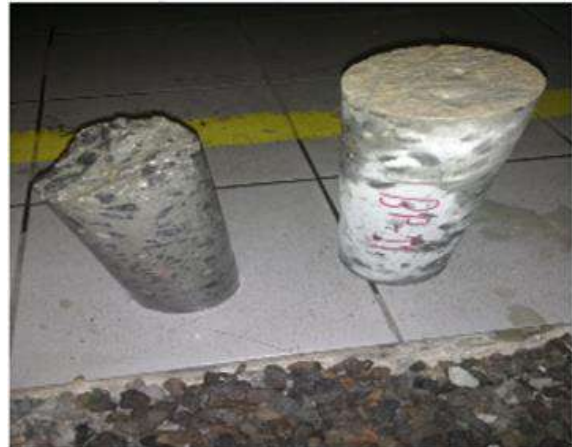
Figure 3.4: Samples
